Attachment A: Digital Images

November 10th, 2008

BOE Building 22nd Floor-Wide Post Mitigation Assessment
Sacramento, CA

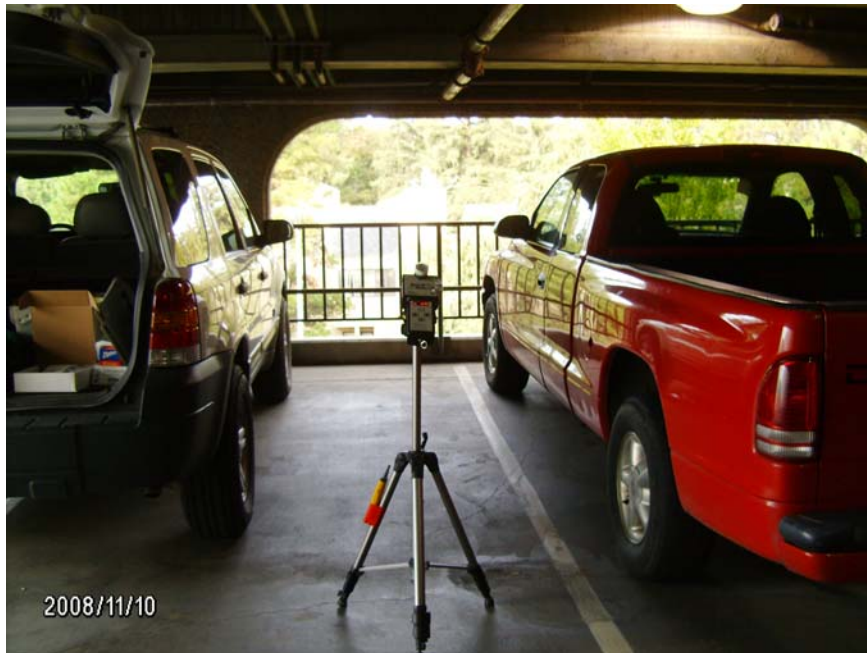
- 1) Image of ambient air sampling location on West side of 3rd level garage building structure located at 450 N Street, Sacramento, California (Subject Building) at time of assessment.

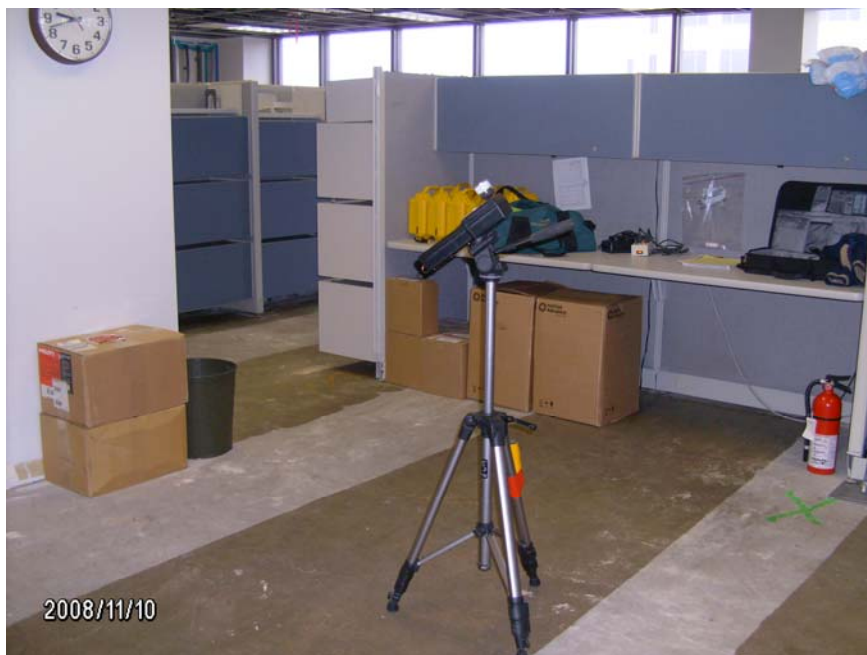
- 2) Image of air sampling performed within northern side of the 22nd floor (construction office area) at time of clearance inspection and sampling assessment.

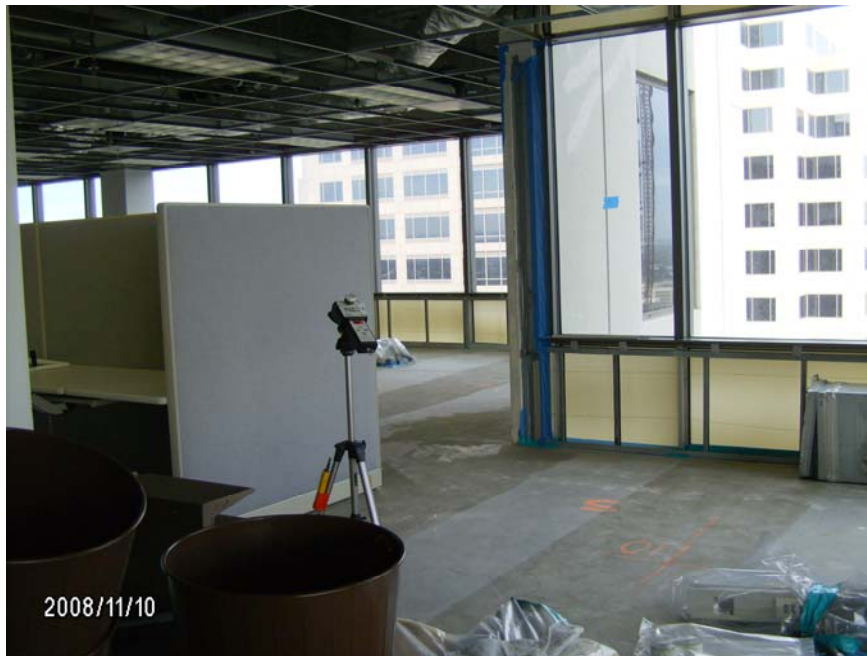
- 3) Image of air sampling equipment location operated within northeastern “punch out” window corner area of 22nd Floor at time of assessment.

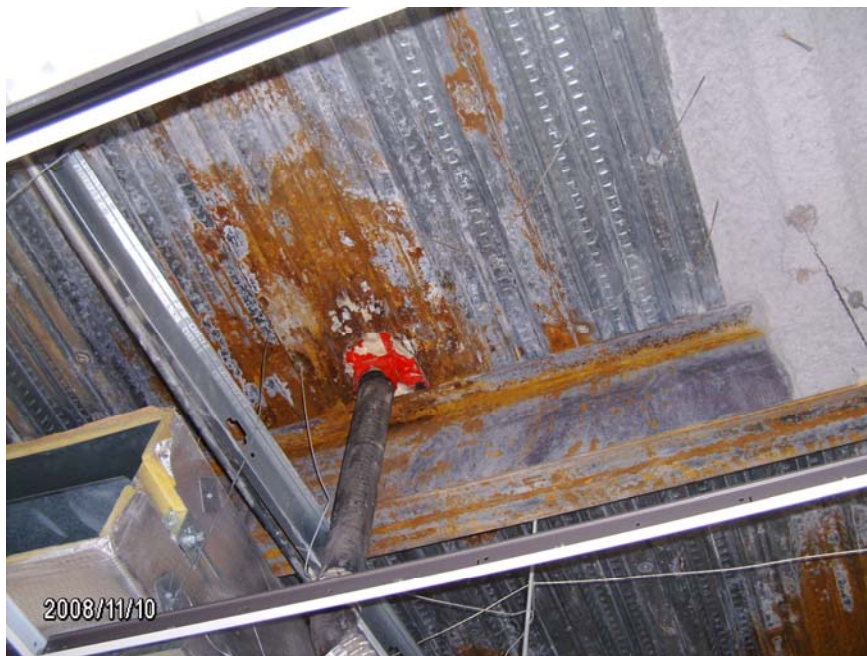
- 4) Image of representative section where fire proofing material had been removed as part of the noted mitigative activity performed within the 22nd Floor.

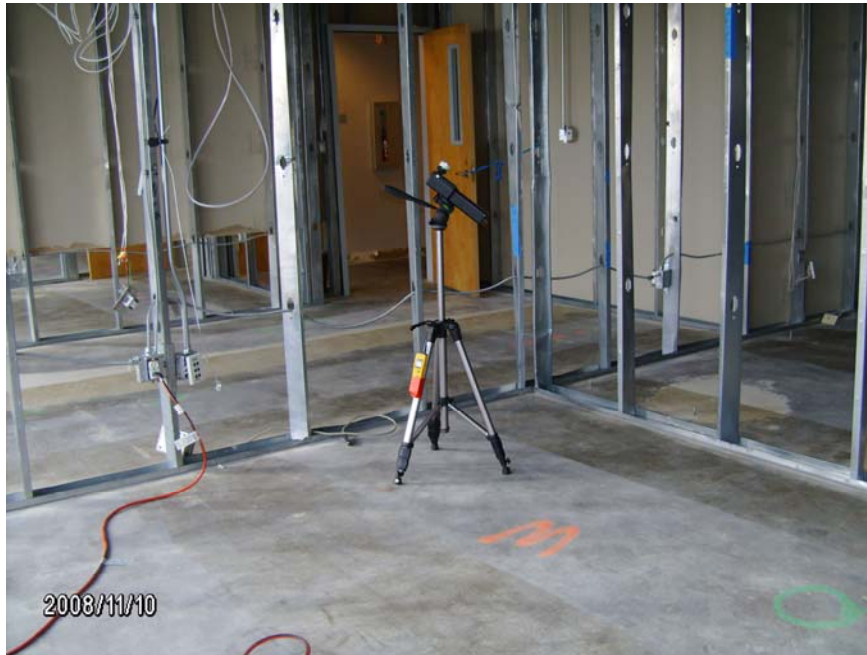
- 5) Image of air sampling activity performed within room 2234 at eastern quadrant of the 22nd Floor mitigative area at time of assessment.

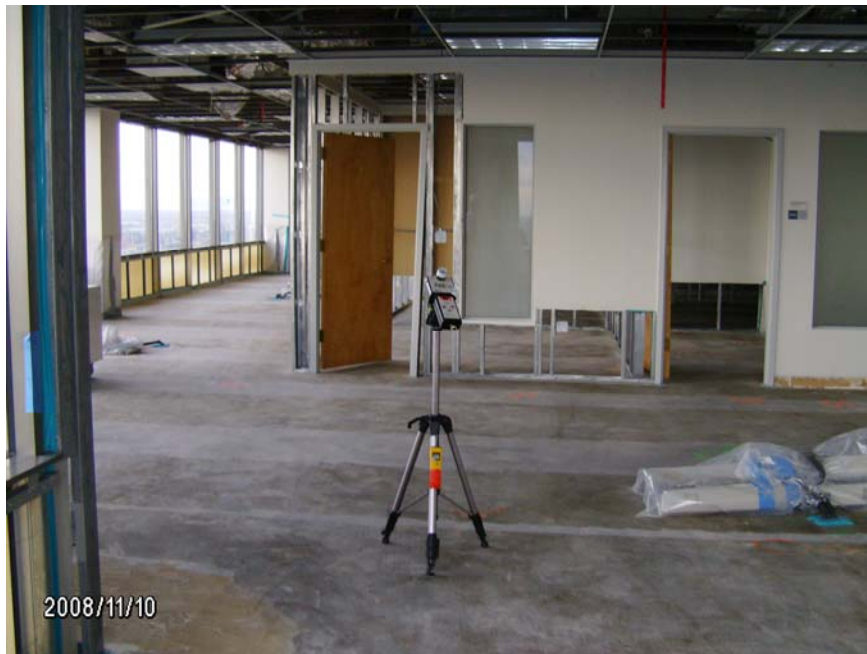
- 6) Image of floor structures and sampling equipment within southeast corner of the 22nd Floor mitigative area at time of assessment.

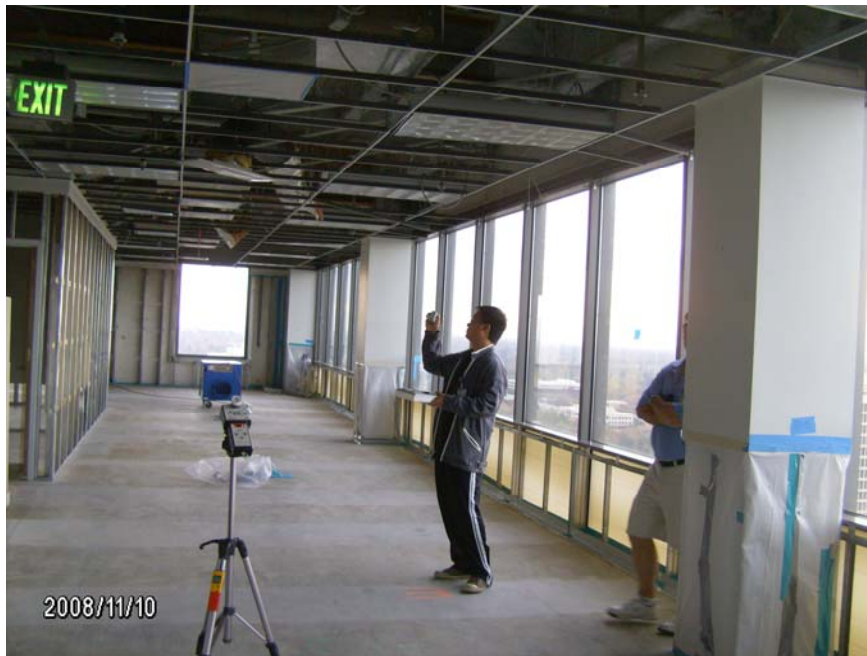
- 7) Image of sampling equipment location within southern perimeter quadrant of 22nd Floor mitigative area at time of assessment.

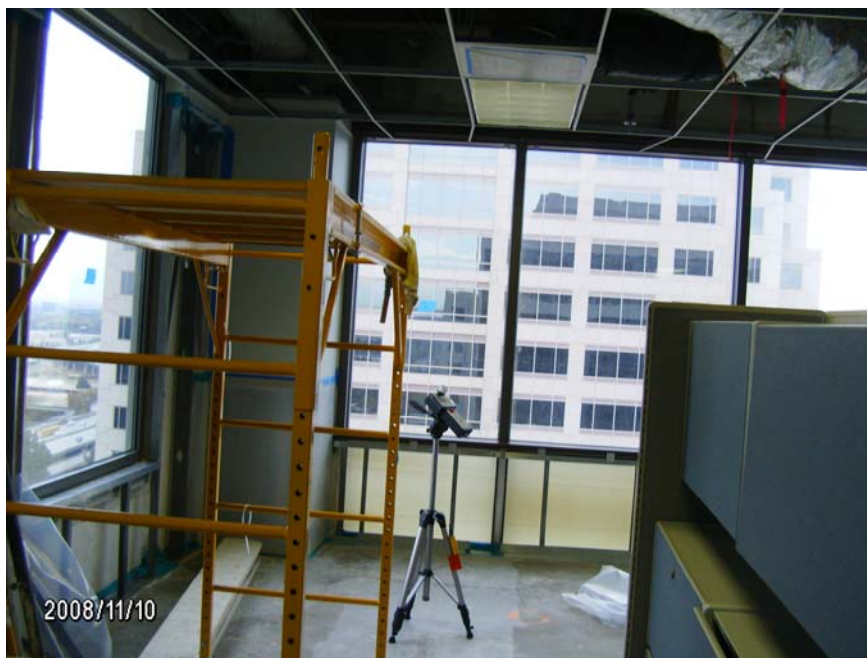
- 8) Image of air sampling performed within northwestern corner area of 22nd Floor mitigative area of subject building at time of assessment.

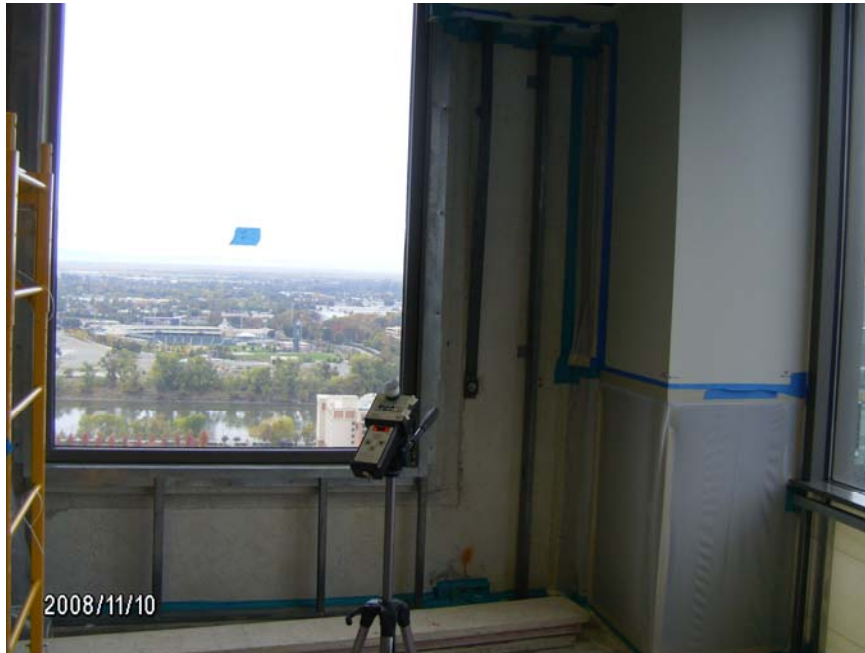
- 9) Additional image of air sampling performed within northwestern corner area of 22nd Floor mitigative area of subject building at time of assessment.

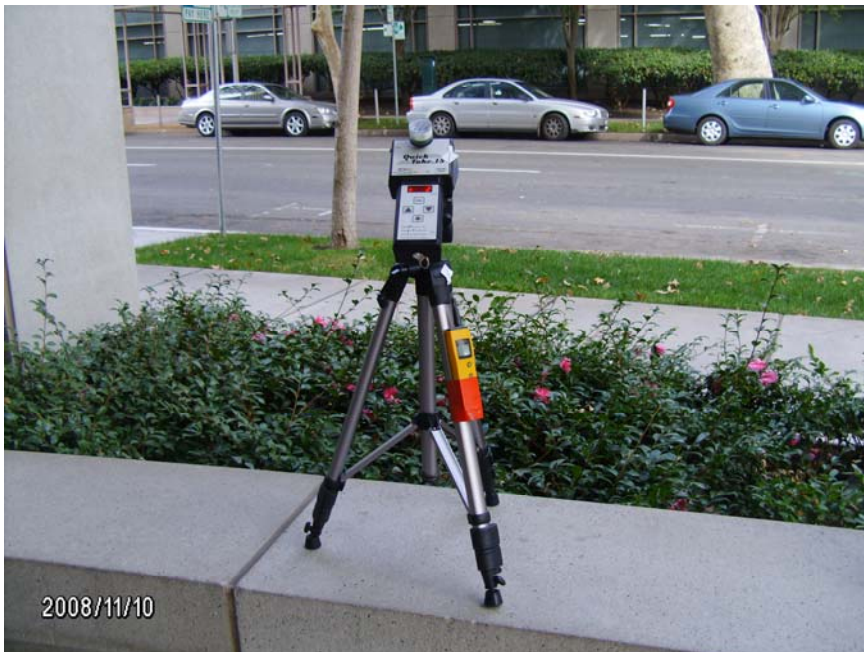
- 10) Image of ambient air sampling performed outside main entry at ground level at the conclusion of interior assessment.
